Investigation of Adaptive Reuse of Heritage Buildings in Penang

N. Jasme¹, M.A. Othuman Mydin^{2,a}, N. Md. Sani³

Abstract. The Burra Charter has defined building adaptation as modifying a place to suit the existing or proposed use. Many historical buildings in the world have been changed or transformed for alternative uses or functions to meet current needs while remaining of significant value to younger generations. In order to protect and manage the historical buildings in Malaysia, various relevant agencies adopted a few general statutory frameworks such as the National Heritage Act (2005) and the Town and Country Planning Act (1979) for implementation at the national level while, for use at the local level, the Guideline for Conservation Areas and Heritage Buildings (GCAHB) is used in George Town, Penang. Even though standards and guidelines have been made, there are still many buildings that have been adaptively reused without following the regulations, thereby, losing the building's authenticity and historical significance. This paper will focus on an evaluation of adaptive reuse buildings in Penang in compliance with the GCAHB.

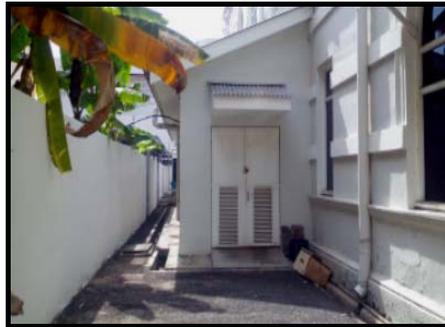
Based on the guidelines, no alteration or extension is permitted as it has footprints and a profile which make it unique to the architectural style of category 1 buildings. In contrast, this building has undergone a small extension on its backside for use as an electrical room. Although it is hiding from general view, it still affects the authenticity of the building's neo-classical style as shown in Fig. 5

Fig. 5: Extension at the backside of the building

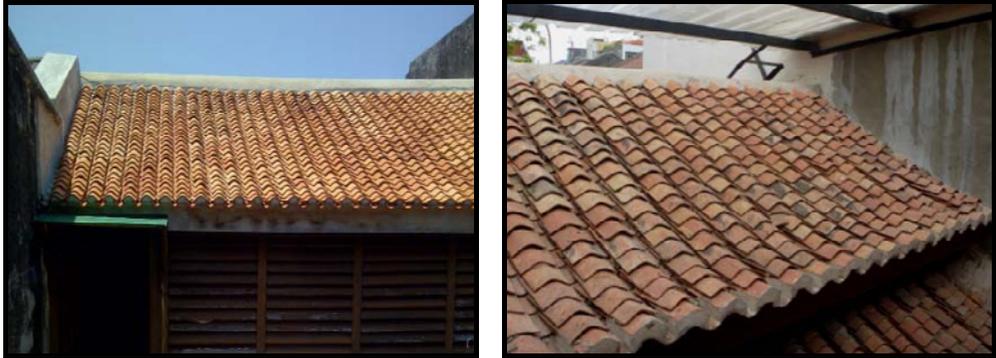
retained its original materials. Additionally, TCM has structurally restored its roof by using a combination of original and new, V-shaped terracotta tiles as shown in Fig. 6. Unfortunately, it was not possible to evaluate the compliance of other parts of the roof of the same museum as well as the entire roof of the BPM.

Fig. 6: V-shape terracotta roof tiles

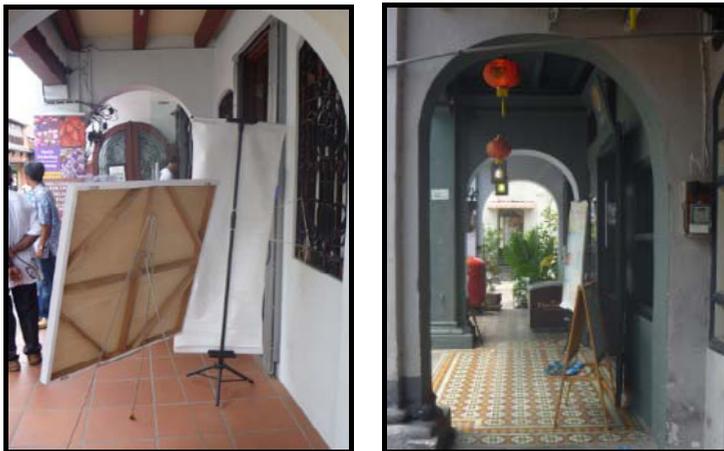
Fig. 7: New terracotta tiles blocking the five-foot way in the BPM (left) and well preserved, coloured pattern tiles with a five-foot way free from obstacles in TCM (right)

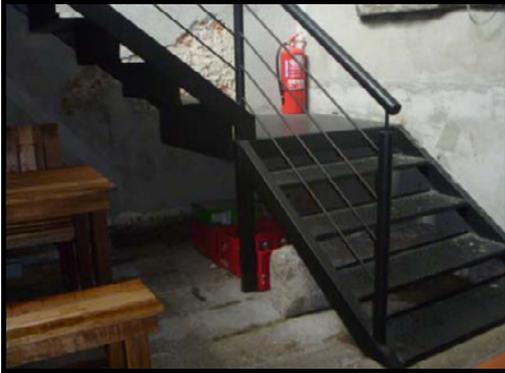
The guidelines state that new structures are not allowed within the air well area. However, the BTM was designed with an open air well on the back side but without a second air well. Unfortunately, in the air well of TCM, a steel staircase has been built as shown in Fig. 8. The stairs is landing near the sunken floor area line with granite stone. Furthermore, the air well is also covered by a transparent roof with sun shading, thus, restricting natural ventilation in that area (Fig. 9).

Fig. 8: Steel staircase at TCM near the air well

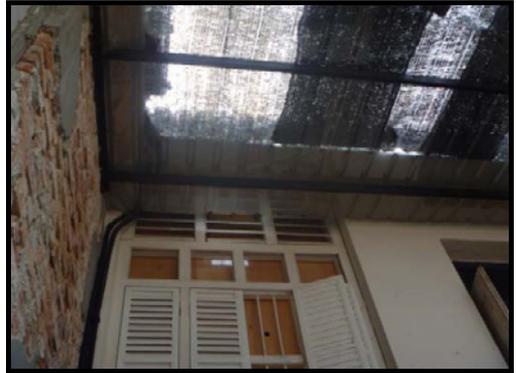
Fig. 9: Air well under transparent roof

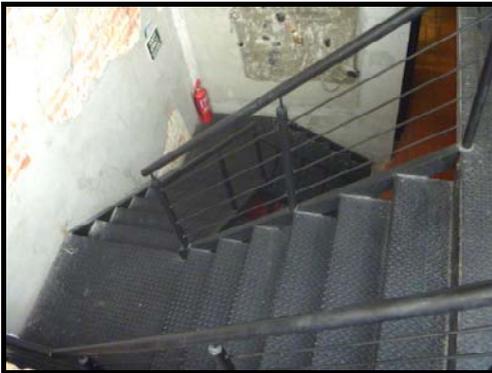
TCM has installed a new, external staircase which is made of steel (Fig. 10) and is removable. The BPM built a new external, concrete staircase with steel handrails for means of escape (Fig. 11). Both serve as a connection from the ground floor to the first floor of each building and follow the requirements set by local authorities and the Uniform Building By-Law (1984).

Fig. 10: New Steel staircase in TCM

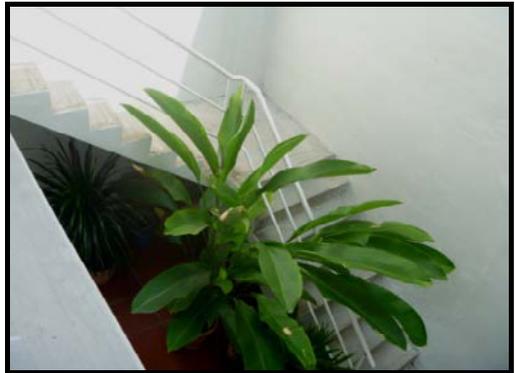
Fig. 11: New concrete staircase in the BPM

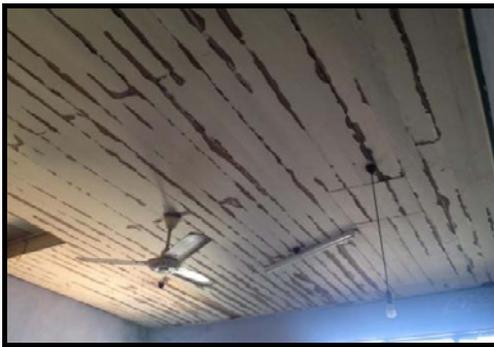
Typically, old shop houses were constructed with timber ceilings to cover the terracotta roof tiles and, sometimes, to act as a loft on upper floors. On the other hand, ground floor ceilings are usually the exposed timber of the floor structure above. This is the case for the three category 2 buildings. The SYSM has preserved the original timber ceiling on the first floor, as can be seen in Fig. 12. However, both TCM and the BPM have changed to suspended ceilings as shown in Fig. 13.

Fig. 12: Original ceiling in the SYSM

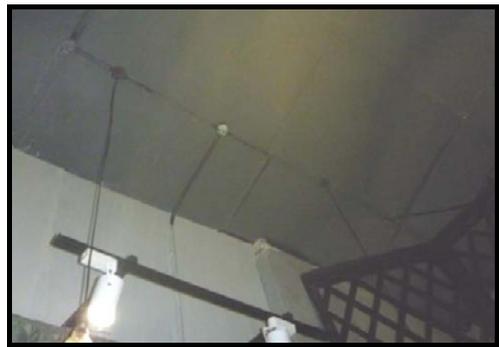
Fig. 13: New suspended ceiling in TCM
