Eartquake Vulnerability Level of Reconstructed Houses, Lesson Learned after Ten Years Java Eartquake 2006

Abstract. Ten years after devastating earthquake May 27 th, 2006, housing reconstruction in the affected area has been done and development is still undergoing. Since then, houses are constructed in various forms and quality. Unrestrained housing development contributes uncertain quality of the buildings in term of building safety. This study examines the level of earthquake vulnerability on the reconstruction houses in the area according to the structural firmness. The method used is by assessing the structural completeness, especially the upper part of building elements, synchronized by the five damages classification for grouping the building affected by the quake. This method is aimed to predict damage level for the future similar earthquake. The outcome of this study shows the level of earthquake vulnerability in the every sub-district. It does also compare the level of building safety differences

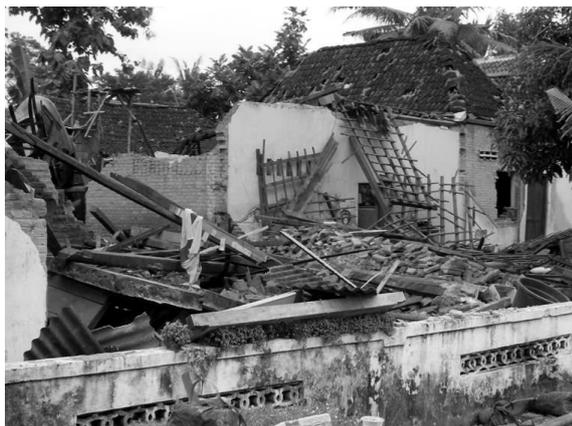
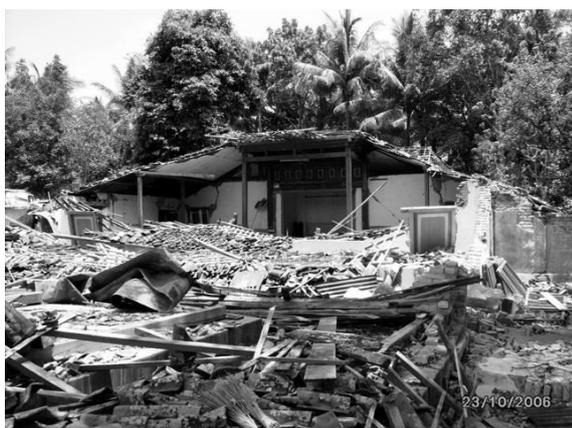
Fig. 1. Destroyed houses of masonry-brick bearing wall.

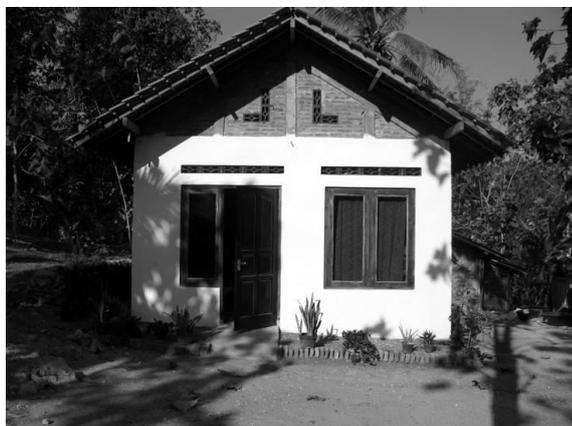
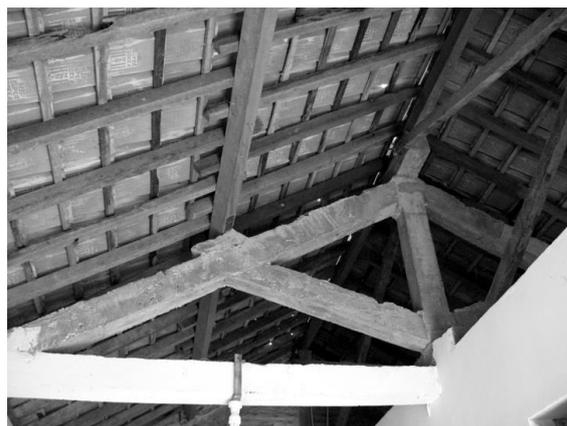
Fig. 2. Reconstruction house and its upper roof reinforced concrete frame structural system.

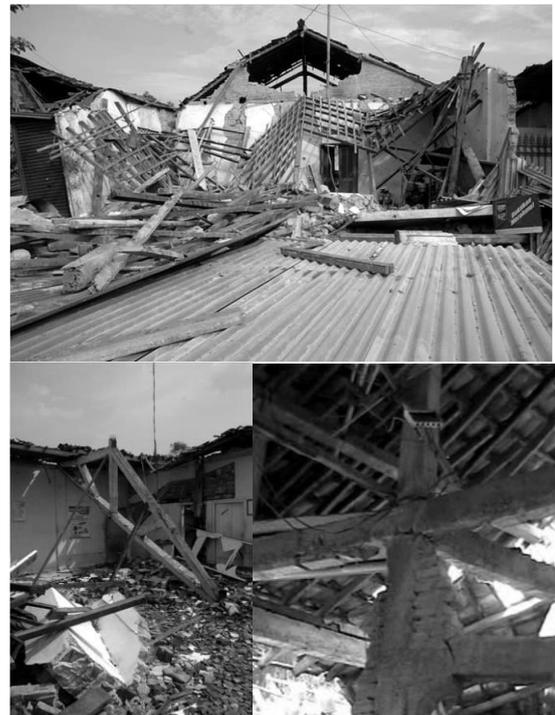
Fig. 4. Roof Structural failed both for bearing brick wall and reinforced concrete frame.
