Analysis of a hazardous factory explosion accident

Shihui Guo, Zhiming Wang, Kunpeng Cui and Chuan Xiao*

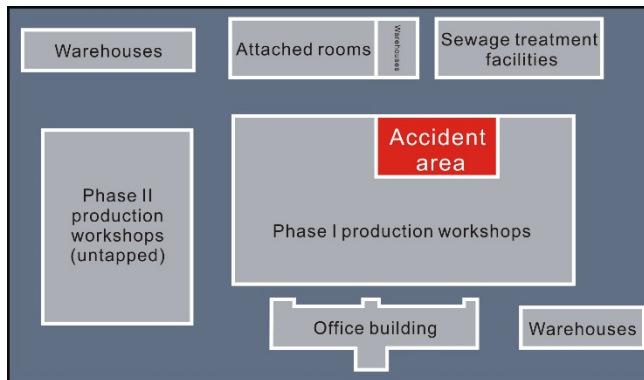
The main buildings of the company's factory area include office buildings, phase I production workshops, phase II production workshops (untapped), warehouses, attached rooms and sewage treatment facilities. The accident area is located in the middle of the north side of the first production workshops (see Figure 1), The workshop is a single-story main frame structure building with a partial two-story west side. The accident area mainly involved the gas cylinder room, cold storage, raw material storage, frying flour room, sieving room, additive storage, sugar storage, steam frying flour room and some rooms in the pastry workshop (see Figure 2).

Fig. 1. Location of the accident.

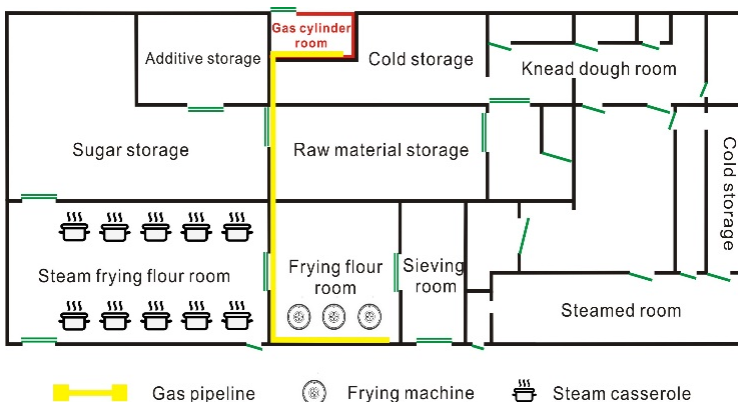
Fig. 2. Regional room layout diagram of accident occurrence.

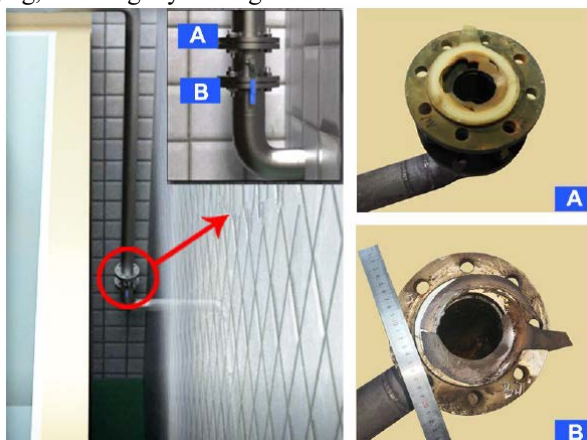
The flange gaskets (Figure 3, A and B) of the main valves of the gas pipeline in the phase I production workshop are made of methyl vinyl silicone rubber, which is subject to long-term corrosion by the mixed gas of liquefied petroleum gas and dimethyl ether in the pipeline. Physical and mechanical performance of the flange gaskets declines. The small cracks develop and gradually grow on the flange gaskets, resulting local breakages. The B gasket is torn and a leak is formed, under the action of the internal pressure of the pipeline. A large amount of gas leaks into the gap between the outer wall of the refrigerator and the surrounding wall in the cold storage, which spreads to the inside of the cold storage, the top space and adjacent areas such as the mixing room, the batching room, the raw material storage, etc.. An explosive mixture of gas in the inner and outer spaces of the cold storage was formed. Meanwhile, the fan in the cold storage also accelerates the mixing of the leaked gas and the air. When an ignition source such as an electric spark explodes, a high-voltage shock wave is quickly formed and spreads around, igniting the combustibles at the scene, leading to an accident. The accident was judged to be a liquefied petroleum gas explosion, and the explosion center was located in the cold storage area.

Fig. 3. Gas pipeline main valve and flange gasket diagram.
