# Assessment of Adaptive Reuse of Heritage Shop Houses for Sleep Lodging in Malaysia: Fulfilment of Conservation Guidelines

M.A. Othuman Mydin<sup>1,a</sup>, N.A. Keling<sup>2</sup>, N. Md. Sani<sup>3</sup>, N.F. Abas<sup>4</sup>

<sup>1,2,3,4</sup>School of Housing, Building and Planning, Universiti Sains Malaysia, 11800, Penang, Malaysia

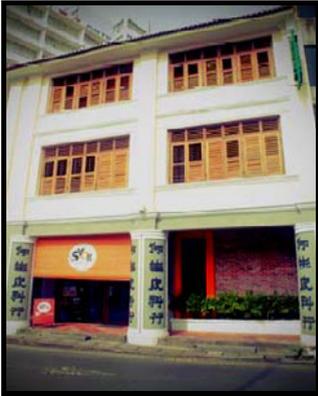
There are only four buildings from the total six that follow the colour scheme as stated in the guidelines. The buildings that follow the requirements are Red Inn Penang, Red Inn Court, Ryokan and Rainbow Lodge. Those four structures are painted with a white colour to accentuate that the building is a heritage building. The other two buildings do not follow the requirements because their colours do not fall in line with the typical characteristics of heritage buildings. For example, the Syok Hostel building is painted a striking orange colour which is not part of the preferred colour scheme (Figure 1). The ideal colour scheme is soft or pastel colours which do not compromise the heritage value. Using vibrant colours may be good for attraction purposes, but, in terms of preserving the

**Figure 2:** Syok Hostel uses bright orange for attraction

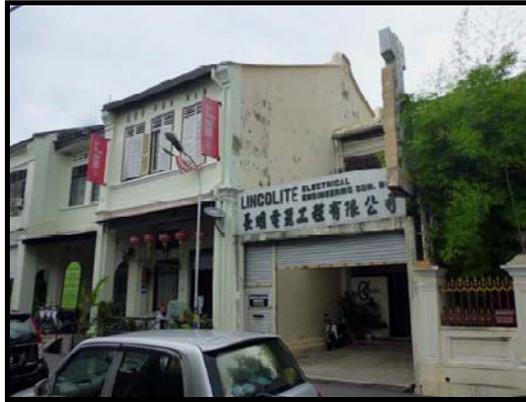
building's historical value, striking colours are not allowed. With regard to Red Inn Heritage, the building is not uniformly painted with the same colours. The front side is a creamy white colour while the side wall is a soft peach colour. The soft peach side is also not properly maintained as the paint has started to blister (Figure 2). Essentially, when too many colours are used, the aesthetic value of a heritage building will be ruined.

**Figure 1:** Red Inn Heritage does not uniformly painting their building with the same colours

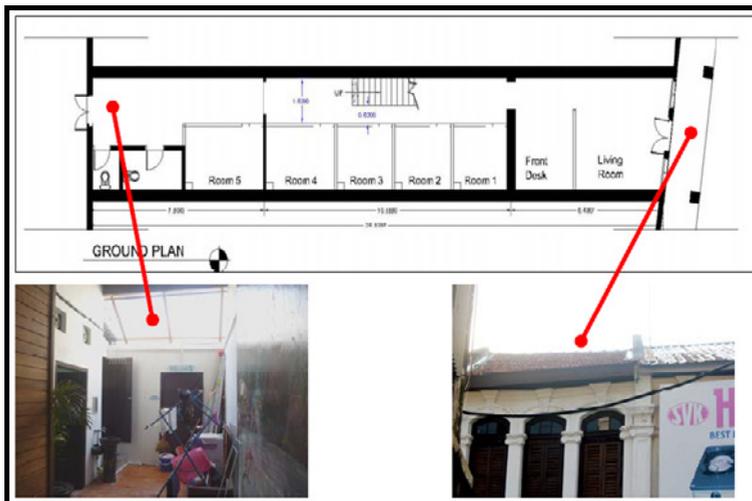
All six buildings in this case study have retained the original tiles with their original installation, but they have only managed to keep some of the terracotta roof tiles. The other part of the roofs has been replaced with metal roofing or corrugated polycarbonate roofs. For example, Rainbow lodge, Red Inn Court, Red Inn Heritage, and Red Inn Penang have all maintained terracotta tile on the front part of the roof, but in the middle and rear part they have used another type of roofing. Changes were made in roofing material because the owners wanted to allow in natural light and to save costs. Nowadays, terracotta tiles are quite expensive and hard to find, therefore, the alternative solution is to allow natural light to enter the building via corrugated polycarbonate which functions as a skylight. It is also a good way to enhance energy efficiency in heritage buildings (Figure 3).

**Figure 3:** Example from the Rainbow Lodge of terracotta tiles in the picture on the right and corrugated polycarbonate skylight in the picture on the left

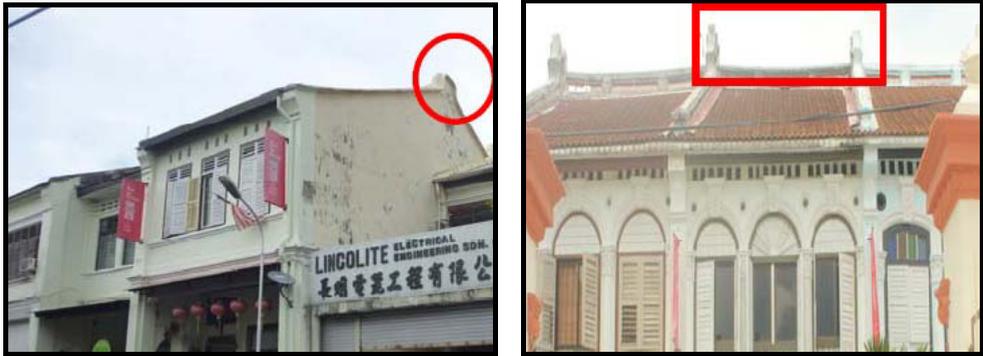
For the Rainbow Lodge, Red Inn Court, Red Inn Heritage, and Red Inn Penang, it can be clearly seen that the roof structures have been retained and restored to their original form. For Syok Hostel and Ryokan, their roofs are difficult to see from below. A horizontal timber purlin has been installed between load-bearing walls from pillar to pillar for these four buildings. A roof ridge with raised vent brickwork can be seen on the Red Inn Heritage and Red Inn Penang (Figure 4). While for the Rainbow Lodge, a V-tiled over joint has been installed from the original structure (Figure 5). All these six cases comprise the latest Penang shop houses, so they contain a middle brickwork party wall which functions as a division with the neighbouring building. This party wall is important because it plays a role in passive fire prevention as it can slow down flames from spreading to the adjacent building.

**Figure 4:** The left picture shows Red Inn Heritage while the picture on the right shows Red Inn Penang

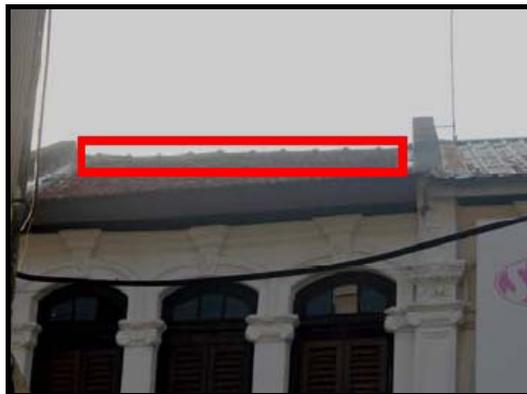
**Figure 5:** V-tiled over joint on the roof ridge of Rainbow Lodge

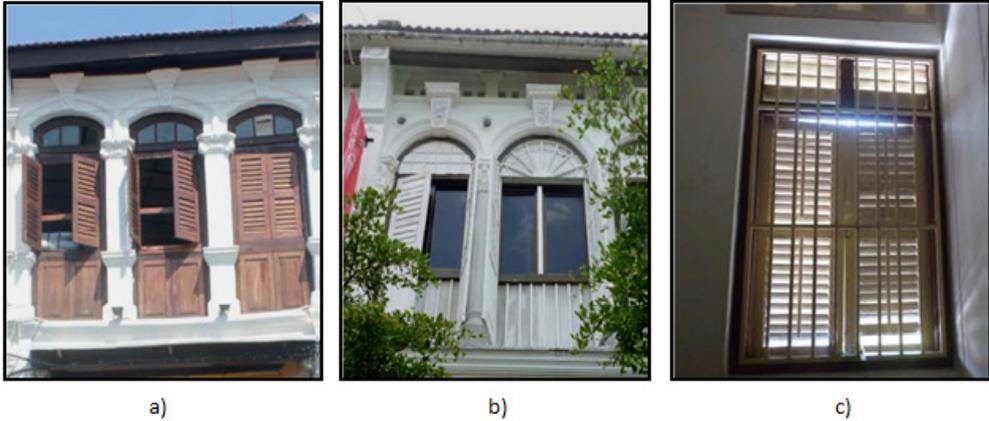
Mostly, buildings that use fixed louver, timber shutters do not have balustrades because the height of the shutter is not very high and the function of balustrades is to prevent people from falling down accidentally. This type of shutter was used by the Ryokan Chic Hostel, Red Inn Court and Rainbow Lodge. However, the Rainbow Lodge has not repaired or reinstated the missing balustrades. Plus, this

sleeping lodge does not have new secondary, internal windows located behind the timber shutter (Figure 6a). The same is true for the Red Inn Court, but for the Ryokan Chic Hostel, internal windows were installed for air-conditioning purposes and to reduce the entering of external noise into the building. New secondary windows have also been applied to the Red Inn Penang, Syok Hostel and Red Inn Heritage (Figure 6b). The Red Inn Penang has balustrades unlike Syok Hostel where no balustrades have been installed. For the Red Inn Heritage, the balustrades have been replaced with window grills made from cast iron (Figure 6c).

**Figure 6:** Actual condition of façade at Rainbow Lodge, Red Inn Penang and Red-Inn Heritage buildings  
 a) Missing balustrade-Rainbow Lodge b) secondary window-Red Inn Penang c) cast iron grill-Red Inn Heritage

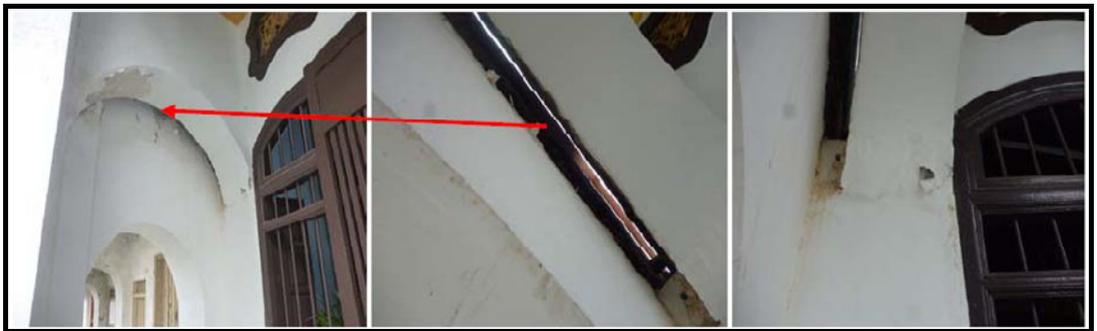
The side facade for Rainbow Lodge is quite dangerous because there is no proper attachment to the adjacent building. From below, a large gap with improper finishing on the side façade can be seen. This area is exposed to the rain and hot weather, therefore, without proper finishing; the structure of the side facade may become damaged. The current situation shows the paint on the surface has started to blister and yellow residue is present due to dampness.

**Figure 7:** Gap between the left side of Rainbow Lodge and the adjacent building

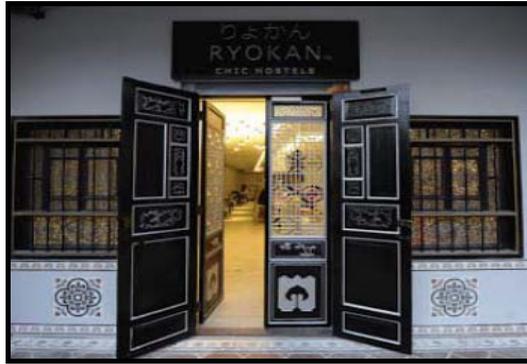
Lime plaster was used for the finishing material of the wall located along the five foot way for all but one of these structures. Unlike the rest, Syok Hostel uses a glass wall for its five foot way walls. Most of these sleeping lodges do not have decorative wall tiles except for the Ryokan Chic Hostel. Ryokan has printed pattern tiles attached to its five foot way wall under the ground floor windows. This tile was newly installed for this shop house's adaptive reuse conversion to a sleeping lodge (Figure 8).

**Figure 8:** Printed pattern tiles on the five foot way wall of the Ryokan Chic Hostel

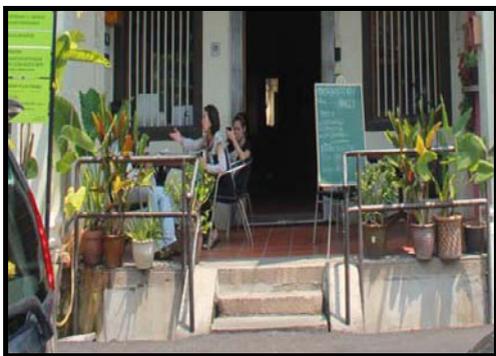
For the flooring of the five foot way, Syok Hostel, Red Inn Heritage and Ryokan use terracotta tiles either in an “I” or diamond shape. Whereas, for the other two sleeping lodges, Rainbow Lodge and Red Inn Heritage use Encaustic tiles for their five foot way floor finishes. Only Red Inn Court has used coloured cement finishes for their five foot way. Granite steps and a bridge across the drain have been used for all these sleeping lodges except for Ryokan (Figure 9). Ryokan has constructed a new, additional, burnt clay brick platform in front of the five foot way. Unfortunately, this platform automatically blocks the five foot way and, as stated in the guidelines; any blockage with a fixed obstruction is not allowed (Figure 10).

**Figure 9:** Example from Red Inn Heritage: terracotta tiles with granite steps and a bridge across the drain

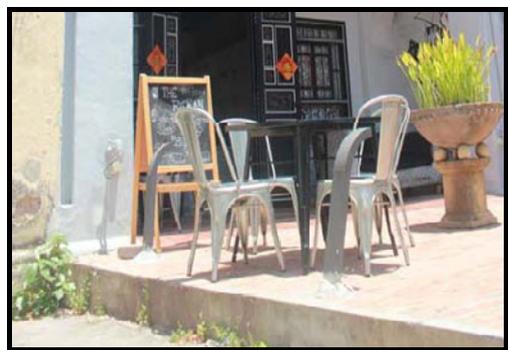
**Figure 10:** Ryokan Chic Hostel with its burnt clay brick platform in front of the five foot way

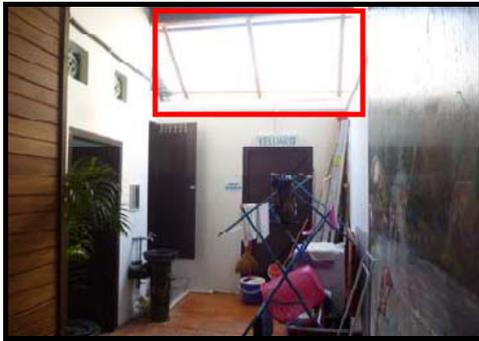
area vacant without any without any specific use. For the Rainbow Lodge, corrugated polycarbonate roofing is used to allow natural light to enter into this space. This roof was installed to give shade because wet clothing is hung there to dry. However, natural ventilation cannot penetrate this space unless the door is left open because Rainbow Lodge has fully covered air well in this area with a corrugated polycarbonate roof (See Figure 11). Unfortunately, Red Inn Heritage has not installed a proper roof. A roof similar to that at Rainbow Lodge is being used, but the roof only covers a small space which is used for hanging clothing to dry (Figure 12).

**Figure 11:** Corrugated polycarbonate as a roof cover for Rainbow Lodge

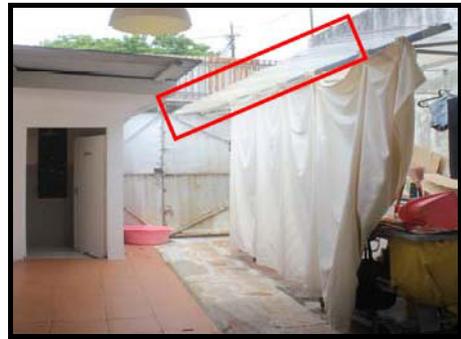
**Figure 12:** Corrugated polycarbonate as a roof cover for Red Inn Heritage being used as a cover for a clothes drying area

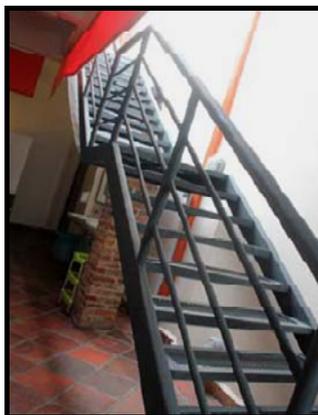
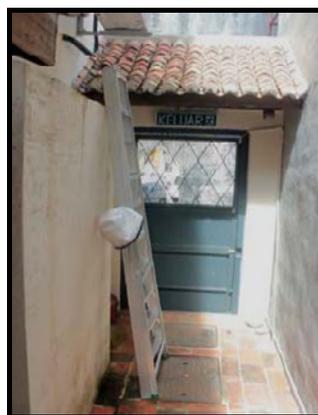
For the Ryokan Chic Hostel and Syok Hostel, this space has been left empty, without any obstacle or roofing system. This is the best choice because this area usually has a lot of toilets and good, natural ventilation is needed so that any odours can leave the space. The other two sleeping lodges, Red Inn Court and Red Inn Penang, do not have any kitchen courtyard or air well. So far, only Syok Hostel has followed the requirements from BOMBA because they have provided an external staircase. Leading to the back lane, this external staircase is needed as a means of escape. The measurements of the staircase are also certified by BOMBA. Furthermore, this staircase is made from steel in order to diminish the risk from fire (Figure 13).

**Figure 13:** External staircase used as a means of escape to the back lane

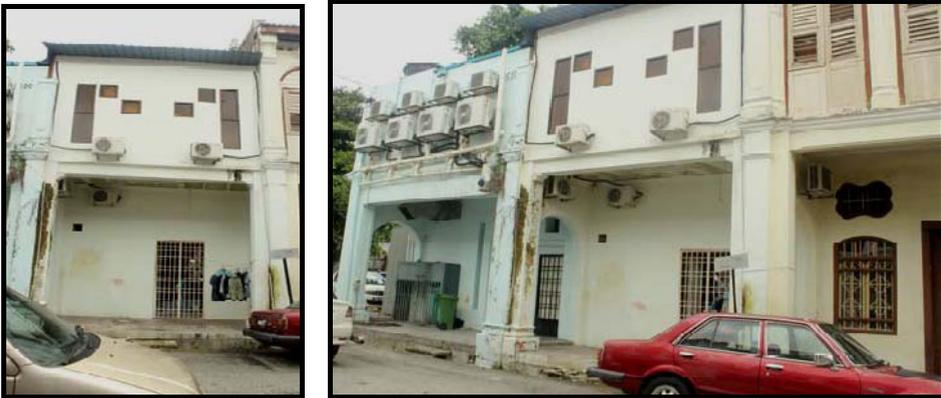
Normally, the rear facade will have a simpler opening than the fancy front façade. However, the material should remain same. This is different with these six case studies which present many changes with new opening materials. Usually, materials will be used that can be easily obtained nowadays such as steel doors and tempered glass windows. The use of tempered glass windows may happen

because of the factor of air-conditioning use in sleeping lodges. For example, the Red Inn Court uses fixed tempered glass windows, fixed on the rear facade at the upper level. This is situated on the back side of the guest room with the air-conditioning system inside (Figure 14).

**Figure 14:** The appearance of the rear façade and the opening which is totally different from the front façade and adjacent buildings

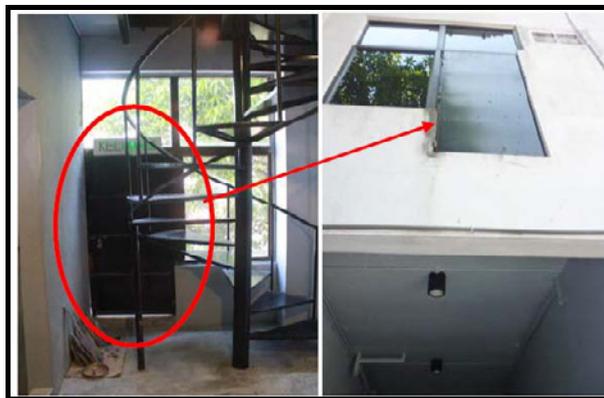
At the moment, only the Ryokan Chic Hostel has constructed a new, additional rear boundary wall. This boundary wall does not have any doors for outward access. Therefore, it is quite dangerous in the event of a fire in this building because there is no means of escape provided at the back. Additionally, Ryokan has also wrongly designed the exit door on the upper floor of the rear facade where there is no walkway or steps to reach the ground below. Should a fire occur, the possibility of victims falling down from a great height is greater than those who will escape from the fire (Figure 15).

**Figure 15:** Exit door on the upper floor and how it looks from the rear facade
