# Relationship between Quality of Building Maintenance Management Services for Indoor Environmental Quality and Occupant Satisfaction: Case Study of Bus Terminal Buildings in Penang

Chong Choon Full<sup>1</sup>, Amin Akhavan Tabassi<sup>2,a</sup>

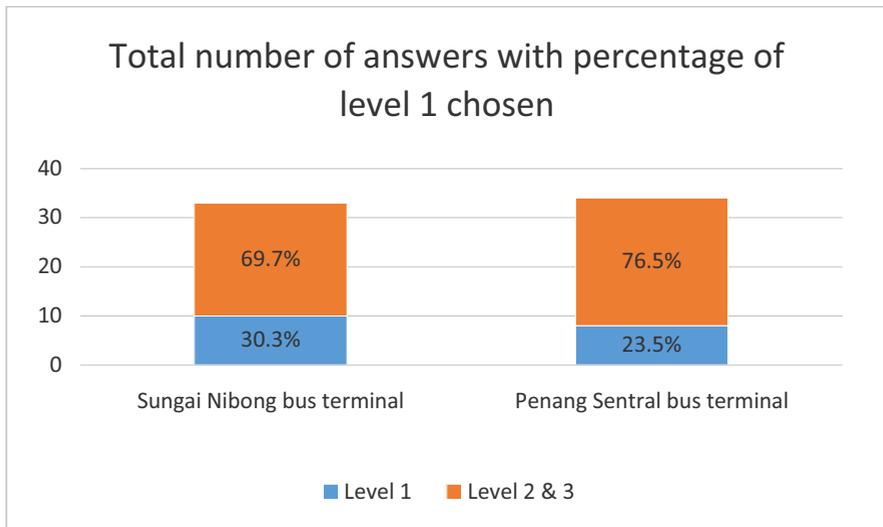
By using the Takakusagi tool, the percentage of level 1 responses in the survey was calculated to evaluate the maintenance service levels of both the bus terminals. To calculate these percentages, of answers that chose level 1 were divided by the total number of answers returned. The building that was rated with higher level 1 responses was the Sungai Nibong bus terminal (30.3%) compared to the Penang Sentral bus terminal (23.5%). This means that the maintenance management services provided at Sungai Nibong is higher compared to those of the Penang Sentral bus terminal. Figure 1 illustrates the total number of answers returned and percentages of level 1 answered in the survey by the administrative person of both the bus terminals.

**Figure 1:** Quality of maintenance management services provided in both the bus terminals

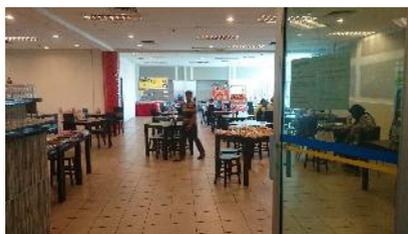
Based on the results, the most satisfied area in terms of thermal comfort inside the Sungai Nibong bus terminal is the dining area. It is an enclosed area with air-conditioning system inside, which adjusts the indoor temperature and humidity to the optimum level as shown in Figure 2. All the air-conditioning systems are in good operating condition. The most dissatisfied indoor thermal comfort noted is pick-up area. It is mainly due to the exposed condition of the area without any HVAC (Heating, Ventilation and Air Conditioning) control system as shown in Figure 3.

Figure 2: Dining area with air-conditioning system

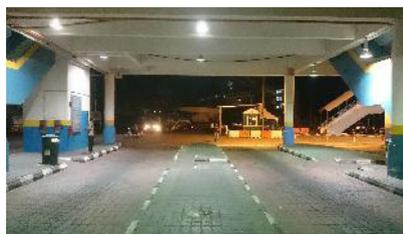
Figure 3: Pick-up area in exposed condition

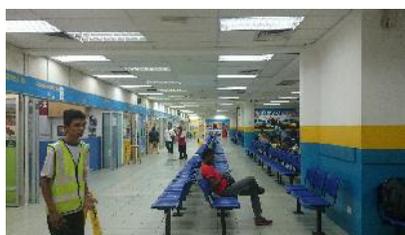
Figure 4: Waiting area in bright condition

The most satisfied area with regards to lighting conditions inside the Sungai Nibong bus terminal is the waiting area. It has fluorescent lighting systems fixed to a suspended ceiling to provide visibility for the occupants. As shown in Figure 4, all the lighting systems in the waiting area are in good operating condition. As for the most dissatisfied area, malfunctioning lighting systems inside the staircase and corridor area was found during the night hours. This problem should be managed and handled well to prevent any unwanted incidences from arising due to the dim surroundings.

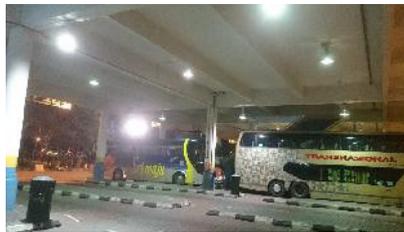
According to the data analysed, the dining area has the highest air quality satisfaction inside the bus terminal. Similar to the thermal comfort issue, this was due to the good condition of the HVAC control system implemented inside the area to control the air flow and air freshness. The pick-up area recorded the most dissatisfaction with its air quality assessment because it is exposed to the external environment, open to dust and dirt from the road nearby. In addition, the buses which get into the platform further produce dirty air and smoke which pollute the area and worsen the air quality. Figure 5 shows the buses which access the platform inside the pick-up area causing higher air pollution.

**Figure 5:** Buses accessing the platforms worsen the air quality

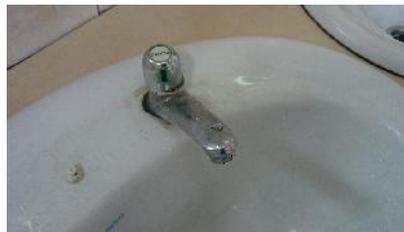
Regarding the issue of cleanliness inside the bus terminal, the waiting area and dining area recorded the most satisfaction. This can be explained by the frequent cleaning services provided inside the building, particularly 2 shifts per day alternatively with 13 cleaners per shift, according to the property manager. The most dissatisfied area is the toilet with a low rating of satisfaction. Throughout the visual inspection, it was observed that the toilet condition inside the bus terminal was pretty bad, in terms of its services and cleanliness. Even though the cleaning services were provided to a large extent, however, facilities were not being properly managed and some were damaged. Figure 6 shows the damage of the handle of a water tap.

**Figure 6:** The handle of the water tap is damaged

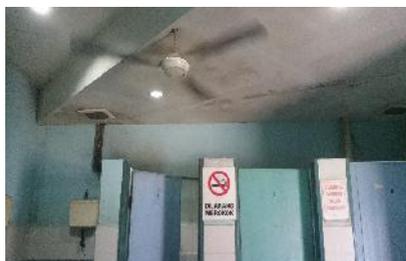
building was exposed to the external ground conditions without an enclosed area with an air-conditioning system within. The toilet had a quite low level of thermal comfort because it is an enclosed area with only a fan inside to maintain the indoor temperature as shown in Figure 7. The waiting and escalator area are both exposed areas with natural air ventilation within the area. Figure 8 shows the fans used fixed on the columns in waiting area. The escalator had no fans or any HVAC control systems inside, however the area was much more comfortable thermally because the area is an exposed area with natural air ventilation.

**Figure 7:** Fan installed in the toilet

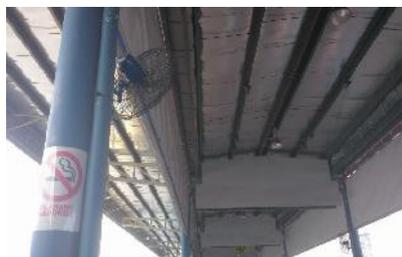
**Figure 8:** Fans fixed on the column

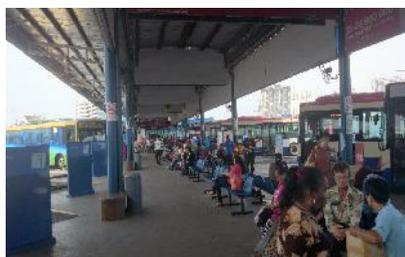
In terms of the lighting conditions inside Penang Sentral bus terminal, the area with the highest satisfaction level is the waiting area, while the lowest is the toilet. This can be explained by the exposed condition and the stronger lighting system provided in the waiting area as shown in Figure 9. Meanwhile, the toilet has the lowest satisfaction level because the lighting system implemented was down lights with weaker luminance.

**Figure 9:** Waiting area with exposed bright surroundings

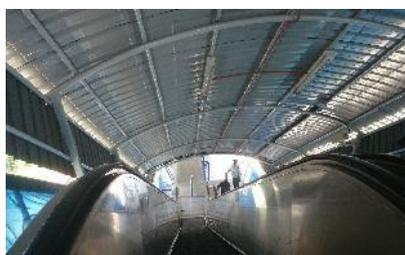
The air quality of all the areas inside the Penang Sentral bus terminal are subjected to dissatisfaction, with highest dissatisfaction level in the toilet area and lowest dissatisfaction level at the escalators. This is mainly because of the exposed condition of the escalator area where air ventilation is stronger with better air flow and air freshness as shown in Figure 10. In comparison, the toilet area has poorer air quality.

**Figure 10:** Escalator area with better air ventilation
