The restoration of the wooden monument church Saint Parascheva from Crivina de Sus, a training for the interdisciplinary project team

Abstract. The restoration project of Saint Parascheva wood monument church, started in 2013 in Crivina de Sus village, from another project initiated by the association AsoP, to study the cultural landscape of the Faget Area, where the oldest wooden monument church in the Bant region in Romania is located. Studies commenced in 2013 have shown us that the wooden church is the central element of the landscape while at the same time being in a precarious state of preservation. In the next years, experimental studies on the monument and its context, realised by specialists and students from areas related to restoration, followed. These investigations have initiated a restoration school that formed an interdisciplinary team for studying and planning restorations of the wooden churches in our region. In the summer of 2018, the actual restoration of the church began, which is also a learning project for the team of restorers and volunteers.

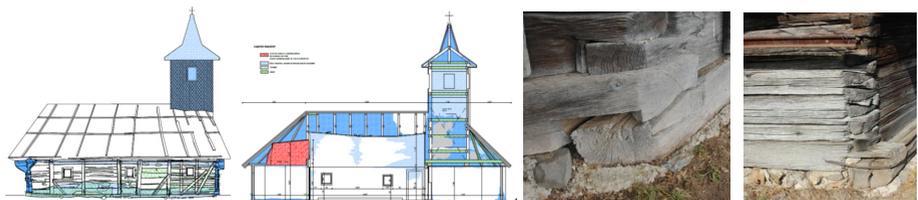
In this workshop, the first research on the wooden church were carried out: measurements, photographic documentation and degradation studies. The findings showed us, the poor conservation status of the monument, which had major roof problems that caused infiltration of water inside, the bottom beams that were rotten and covered with earth and wall and tower structural deformations.

Fig. 3. A first decay survey, decay and structural problems (original)

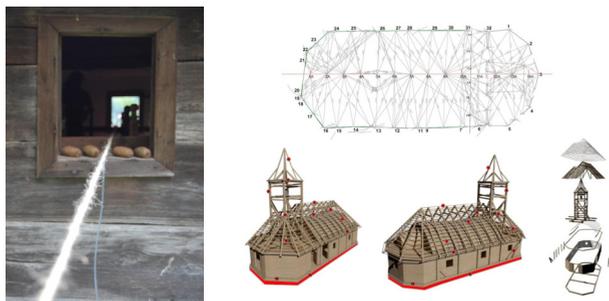
The summer workshop in 2014 was organized similar to the previous year, and we continued the before started studies. A detailed survey of the church using the spatial axis method ("vagris") was carried out, through which we began to understand how the structure of the church and its components work together, as well as its structural and biological problems and deformations. In compare we realised also a photogrammetric survey of the interior and exterior of the church.

Fig. 4. Traditional survey using defined axes (vagris) / 3d model based on the traditional survey (original)

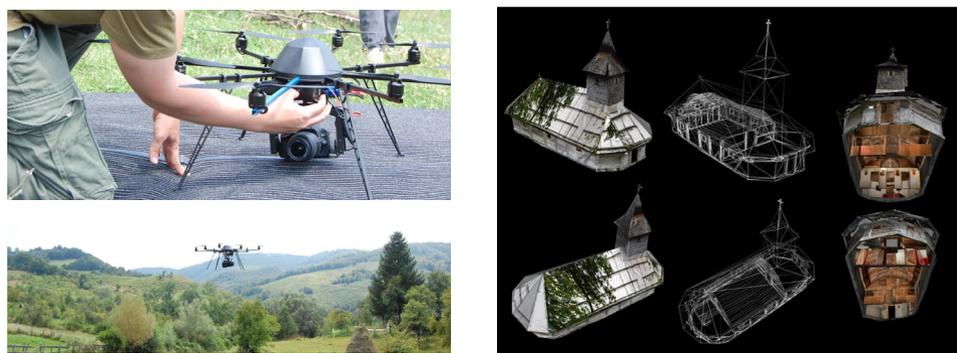
Fig. 5. Photogrammetric survey / 3d model based on the photogrammetric survey (original)

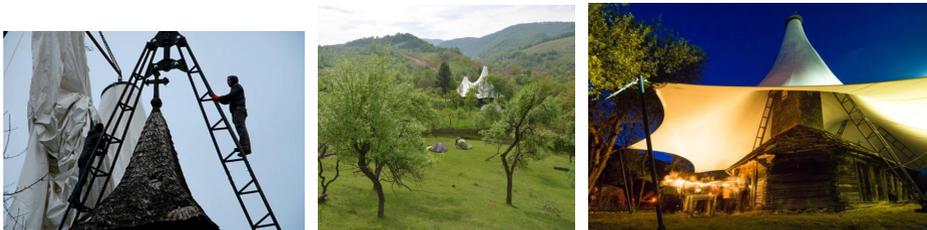
In the winter of 2015 for three days (18-20 December 2015) the tensile scaffolding was mounted over the wooden church. The team of volunteers and specialists was formed by ing. Dragoş Dumitrescu and two members of his company who produced the membrane, and ing. Radu Diaconovici and the team of his company who had previously installed the metal screwed foundations, Valeriu and Claudiu Armene, who raised with a crane the tense structure over the church and many other volunteers.

Fig. 7. The scaffold mounting / the ready mounted scaffold (original)

That year, the next step of the project was planned, to place a covering structure to protect our church. It had to meet more specific needs: the church had to be covered with a structure allowing the work space at the level of the roof and the tower at the time of the

restoration, it had to be a totally reversible structure on the cemetery around the church, so no concrete foundations were allowed! The structure had to be easy to mount and dismantle to be easily moved after the restoration on another church that requires protection. Many types of covering structures were studied, and the most appropriate showed to be a tensile structure on metal posts that became a "landmark".

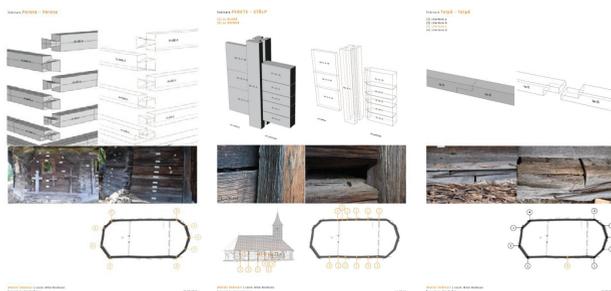
Following the scaffolding and the removal of the old degraded shingles, at the summer workshop in 2016, we had access to the upper part of the church, and we were able to record and draw up analytical charts for the wooden elements. In parallel, we studied the typologies of joints, constructive techniques used, identification of historical tools of manufacture, the documentation of signs and traces that the wood carries, which all talk about the past of the church, the society that generated it and used it. An historical study based on written sources was started, by studying all the archives we found. There was also a session of interpretation of the data collected up to that point from the historical study, dendrocronological analysis, traces and techniques used, in order to obtain an overall interdisciplinary picture of the church.

Fig. 8. Typology of joints (original)

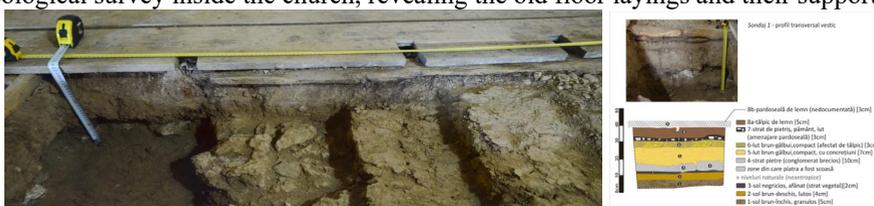
We had invited an archeologist who became a part of the project, who made a first archaeological survey inside the church, revealing the old floor layings and their support.

Fig. 9. The archeological survey (original)

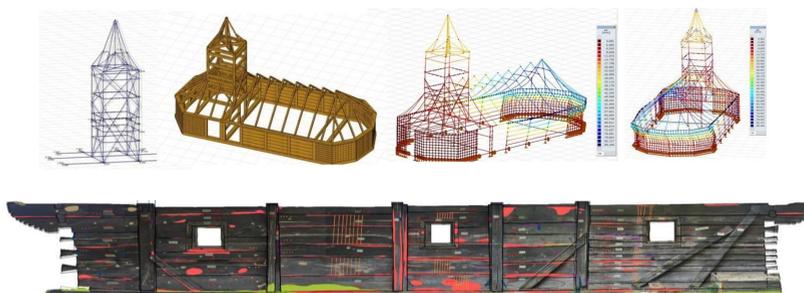
Fig. 10. Putting face to face of the specialties: structural expertise, decay survey, the historical study (original)

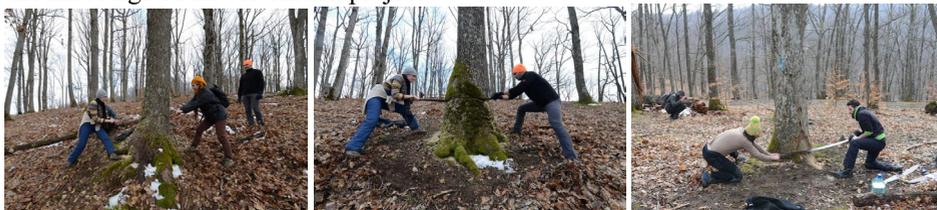
Fig. 12. Traditional oak lumbering (original)

On Feb. 12, 2018, in the vegetative rest period and a decreasing moon, six oak trees were traditionally manually cut, necessary to replace the rotten bottom beams of the church. This was the first stage of the restoration project.

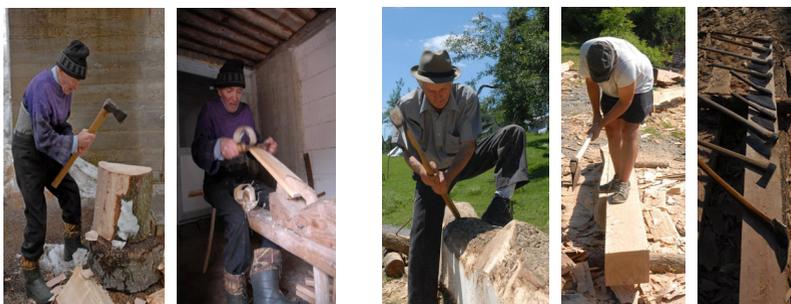
Fig. 13. Traditional shingle cutting / Traditional wood carving (original)

In the summer of 2018, the traditional shingle fabrication was started by “Nicolae” an old craftsman, with which the church is to be covered.

Also the manually oak tree carving started in order to replace the bottom beams of the church by our craftsmen team: Toader Nicolae, Ioan Cioara, Florin Lazarescu and Corneli Toader.

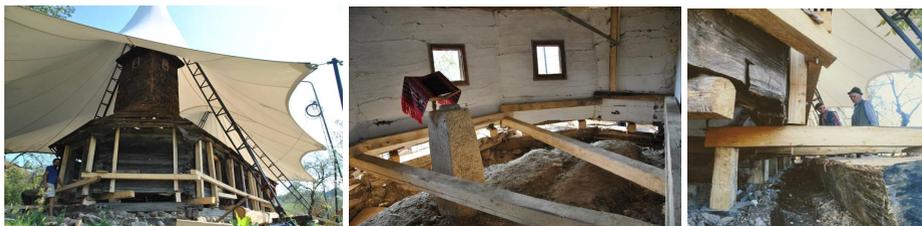
Fig. 15. Raising of the church and replacing of the decayed bottom beams (original)

In September, the third stage of restoration work began, in which the wooden church was raised entirely by means of a stiffening structure, approx. 60 cm from the initial elevation. Once the church was raised, it was possible to change the bottom beams and work underneath them to build the stone foundations.

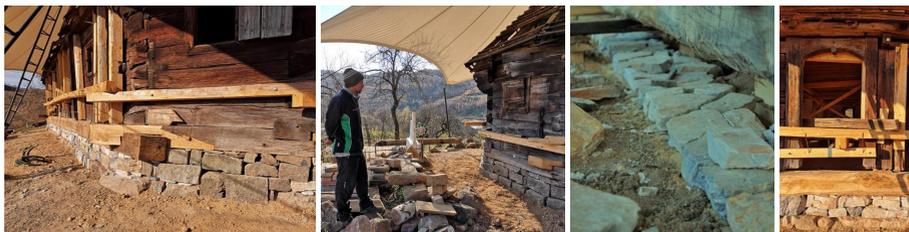
Fig. 16. The replaced bottom beams and the stone foundation (original)

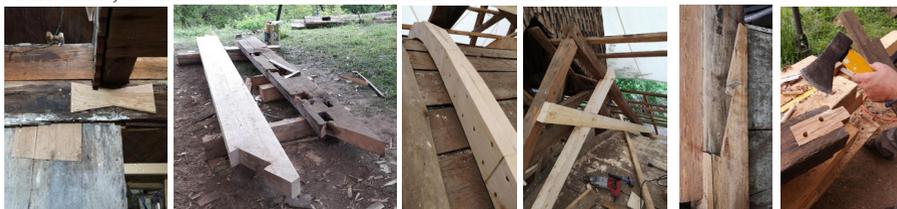
Fig. 17. Lockings / squeles of some decayed structural parts, new structural elements to strengthen the structure (original)

In May-June 2019, the fourth stage of restoration work began, consisting of interventions at the upper part of the church, plumbing and changing of some degraded elements. Also, the rest of the structural reinforcement interventions were carried out, to the wooden vault, at the roof structure and at the tower structure.

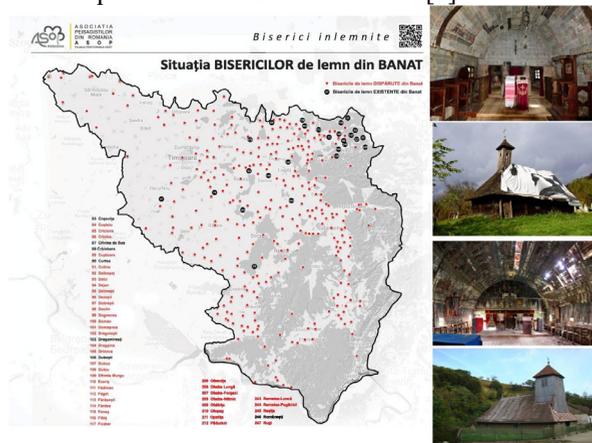
Fig. 18. Past / present situation of wooden churches in Banat region (original + Wikipedia)

Only in the western part of Romania we have left over 300 monument wooden churches, many of which require restoration interventions. [7]

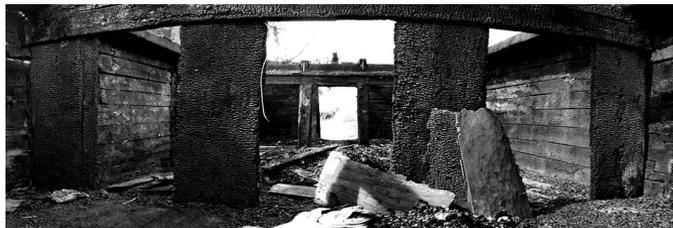
Fig. 19. next step: a future project for the interdisciplinary team, the burnt monument church " Saints Archangels Michael and Gavriil " Povergina village (original)

The next objective of the new interdisciplinary team of specialists and craftsmen is the beginning of the studies, the restoration project and the intervention for the wooden monument church "Sfintii Arhangeli Mihail si Gavril" in the town of Povergina, which partially burned in 2016.
