Investigation of Adaptive Reuse of Heritage Buildings in Penang

N. Jasme¹, M.A. Othuman Mydin^{2,a}, N. Md. Sani³

Abstract. The Burra Charter has defined building adaptation as modifying a place to suit the existing or proposed use. Many historical buildings in the world have been changed or transformed for alternative uses or functions to meet current needs while remaining of significant value to younger generations. In order to protect and manage the historical buildings in Malaysia, various relevant agencies adopted a few general statutory frameworks such as the National Heritage Act (2005) and the Town and Country Planning Act (1979) for implementation at the national level while, for use at the local level, the Guideline for Conservation Areas and Heritage Buildings (GCAHB) is used in George Town, Penang. Even though standards and guidelines have been made, there are still many buildings that have been adaptively reused without following the regulations, thereby, losing the building's authenticity and historical significance. This paper will focus on an evaluation of adaptive reuse buildings in Penang in compliance with the GCAHB.

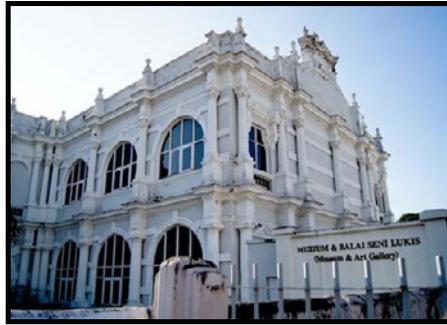
Fig 1. Penang State Museum

| Name | Building Description |
|---|---|
| Penang State Museum (Fig. 1) | The building was formerly used as a school building and originally had two wings which included a right wing, completed in 1986, and a left wing, in 1906. The left wing was completely destroyed by Japanese aerial bombing during World War II and was never rebuilt. |

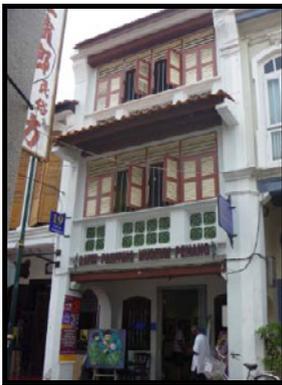
Fig 2. Batik Painting Museum

| Name | Building Description |
|---|---|
| Batik Painting Museum (Fig. 2) | This category 2, three storey building is an example of the "Early Straits" Eclectic Style and is believed to have been built between the 1890's to 1910s. It is located at 19 Armenian Street and started operating as a museum in October 2013 after undergoing 2 years of restoration work. |

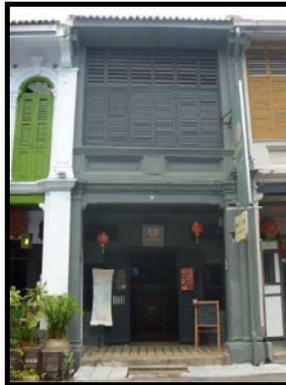
Fig 3. The Camera Museum

| Name | Building Description |
|---|---|
| The Camera Museum (Fig. 3) | The backside of the ground floor of this "Southern Chinese" Eclectic Style shop house is currently used as a café and gift shop, while the first floor is fully used as a museum featuring a collection of vintage cameras. |

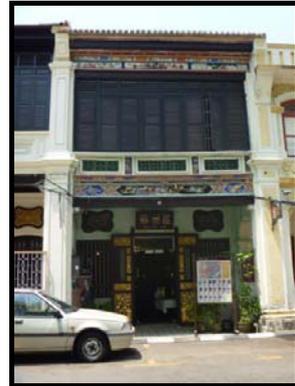
Fig 4. Sun Yat Sen Museum

| Name | Building Description |
|---|---|
| Sun Yat Sen Museum (Fig. 4) | In the past, this building was used as a meeting place and residence for Dr. Sun Yat Sen during China's revolution. With a similar architectural style to the previous building, the ground floor is fully serves as Sun Yat Sen's Museum, while the first floor is used as a hostel. This building underwent a restoration process in 2010 |
