Eartquake Vulnerability Level of Reconstructed Houses, Lesson Learned after Ten Years Java Eartquake 2006

Abstract. Ten years after devastating earthquake May 27 th, 2006, housing reconstruction in the affected area has been done and development is still undergoing. Since then, houses are constructed in various forms and quality. Unrestrained housing development contributes uncertain quality of the buildings in term of building safety. This study examines the level of earthquake vulnerability on the reconstruction houses in the area according to the structural firmness. The method used is by assessing the structural completeness, especially the upper part of building elements, synchronized by the five damages classification for grouping the building affected by the quake. This method is aimed to predict damage level for the future similar earthquake. The outcome of this study shows the level of earthquake vulnerability in the every sub-district. It does also compare the level of building safety differences

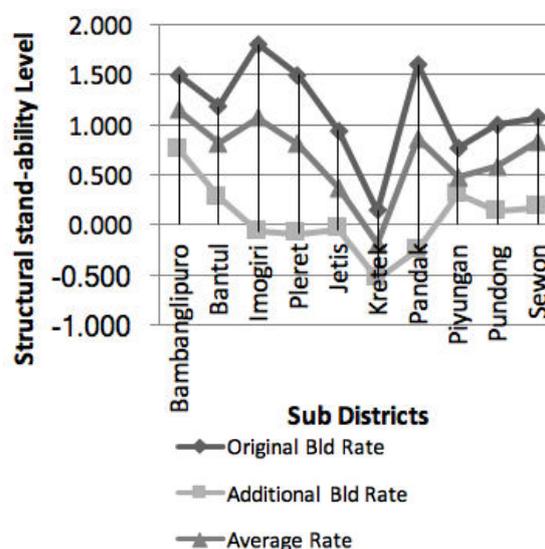
Fig. 7. Result chart of stand-ability level which is directly in opposite with vulnerability level of the houses.

Structural stand-ability level from earthquake shake which is defined by points system from +2 to -2 is applied for all data in the every sub-districts. The outcome shows that all levels are found in the areas. In general, all original reconstruction houses level are always above the additional houses. The levels of original and additional houses are not always parallel, and even some sub-districts such as Imogiri and Pandak have big difference between the two. Point system applied to samples had shown that -1 to 2 point levels had been found in almost the every sub-district. Unfortunately there are level -2 for original reconstruction house in the four sub-districts; Kretek (2 cases or 6.66% data), and Pundong (1 case or 3.33% data). For additional building, the -2 level is also found in Bantul (1 case or 3.7% data), Imogiri (1 case or 3.33% data), Kretek (7 cases or 23.33% data), and Pundong (3 cases or 10% data).

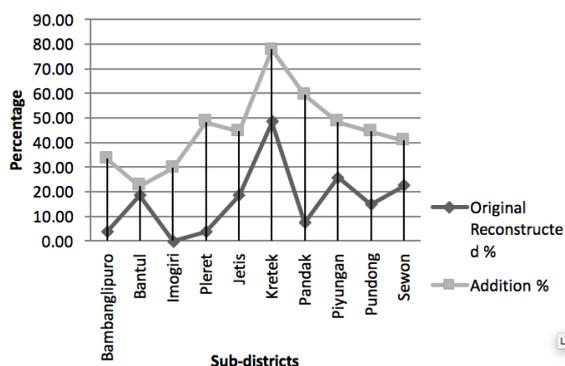
Fig. 8. Percentage of Non-Acceptable Reconstruction houses which directly shows the level of vulnerability.

Building vulnerability as lower level of acceptable structure or stated as non-acceptable is defined by percentage of failed house from the total sample in the area. Again, as shown in structural stand ability examination, the additional buildings have higher vulnerability. However, this examination considers only the amount lower level quality without concerning the higher as accepted group. This is useful method in order to focus the vulnerability level. The chart shows that the areas having higher level in structural stand-ability are not always have less percentage in vulnerability. Furthermore, only one district (Imogiri) that have 100% of original new reconstruction houses are accepted (0 to +2 levels), however, the rest of sample areas have unacceptable houses. Unfortunately, this is not followed by new additional buildings which are found in every sub-district with the unaccepted percentage starting from 20% to almost 78%. This is showing us that, by this way, the complete situation on vulnerability of reconstruction houses can be identified more clearly.
