Appraisal of Fire Safety Management Systems at Educational Buildings

N. Nadzim¹, M. Taib^{2,a}

Two educational buildings were selected as case study buildings on Penang Island. The selected buildings were Sekolah Jenis Kebangsaan (Cina) Min Sin and Sekolah Menengah Kebangsaan Abdullah Munshi. The reason of choosing these schools was because they had both experienced fires last year, in 2013. The fires destroyed a few parts of the buildings, however, no injuries were sustained. Sekolah Jenis Kebangsaan (Cina) Min Sin is located at 86, Jalan Tun Dr. Awang, Relau, 11900 Bayan Lepas, Pulau Pinang. The building was built in 2004 and consists of three blocks which are Block A, Block B and Block C. A guard house was fully burnt and the cause of fire was due to a short circuit. Sekolah Menengah Kebangsaan Abdullah Munshi is located at Jalan P.Ramlee, 10460 George Town, Pulau Pinang. The building is comprised of six blocks within the school premises. The fire incident happened in a corridor near the entrance to the school canteen. The cause of fire was also from a short circuit caused by old wires. It was important to conduct site visits to both of these schools in order to identify the c

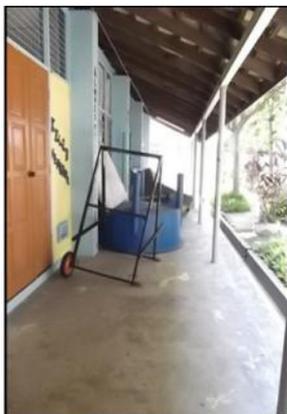
Both schools have their own housekeeping services. Housekeeping services are responsible for cleaning up rubbish and dusting, disposal of rubbish, cleaning up after workers and keeping travel areas tidy, well-lit, and ventilated. From observations at SMK Abdullah Munshi, the school failed to keep a few areas in the school building tidy, especially along the escape route. Figure 1 shows unused furnishing materials left unattended outside a classroom. They were left along the corridor and affected the overall width of the walkway. Figure 2 shows other wooden materials placed at the centre of the walkway to a classroom and the canteen. The materials were quite big in size and obstructed the walkway passage from being clear.

Fig.1: Unused and broken materials are left along the corridor outside the classroom

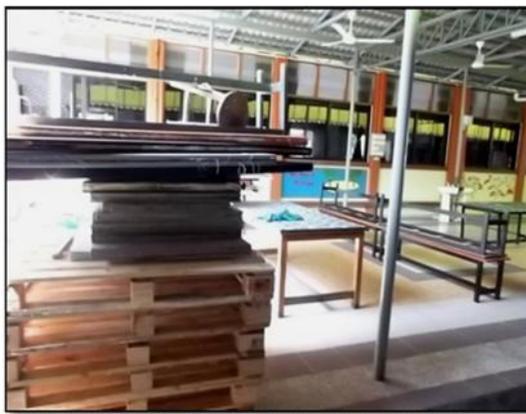
Fig.2: Flammable materials are placed at the centre of the passage

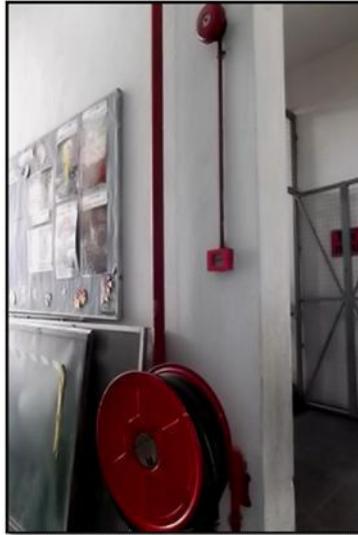
When emergencies happen, someone gives a warning to the other occupants in the building using a manual break glass call point. Once triggered, the alarm will continue to sound out automatically. Fire alarms had been installed on every floor for both of the school buildings. Figure 3 shows the fire alarm installed on every floor of SJK (C) Min Sin. When someone breaks the glass, the action will then connect the alarm panel board. Then, from the board, the sound will release. The indication zone with red light in the panel board shows which parts of the building are experiencing a problem or emergency. The system is located on exit routes, close to the hose reel. As such, nobody in the building needs to travel more than 30 metres to access it. The system is mounted at a height of 1.4m from the floor, easily accessible and well illuminated.

Fig.3: Break glass installed on every floor of the building with a hose reel

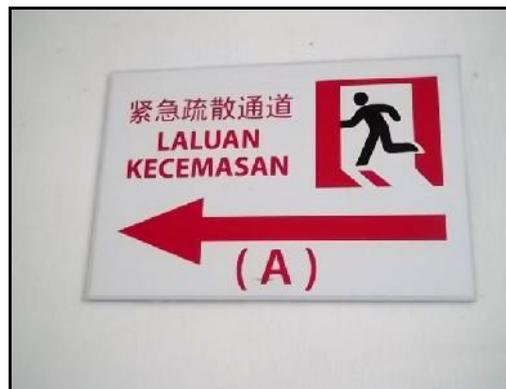
Both schools had already implemented fire escape signs to inform the occupants which routes they should take to escape from fire. Figure 4 shows the escape signs in SJK (C) Min Sin which are attached to the wall near the staircase. In SMK Abdullah Munshi, red arrows were used to indicate the escape routes. The occupants will refer to the arrows which indicate the direction to a safe place (place of assembly). Figure 4 shows the escape signs that are used in SJK (C) Min Sin. They are located at every floor and the signs are clearly visible for everyone to see.

Fig.4: Escape sign

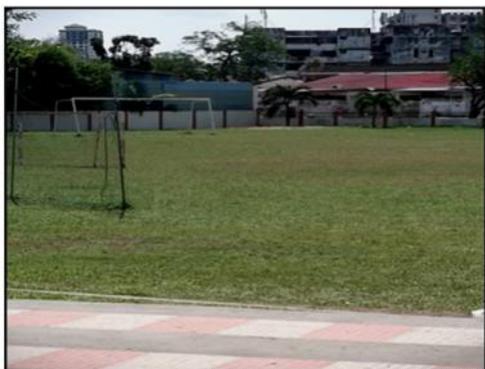
The condition of the place of assembly is in good. Figure 5 shows that the school field at SMK Abdullah Munshi, which is used as the place of assembly, is properly maintained in that the grass is cut short and there are no obstructions or rubbish. Figure 6 shows a place of assembly for SJK (C) Min Sin. The place of assembly is chosen by the fire brigade with consideration for the requirements stated in the laws and regulations. There are three places of assembly for this school. Place A and Place B are located in front of the building, while Place C is located at a small field behind the school building. During a fire, the occupants will move to the nearest place of assembly which can accommodate the total number of occupants in the building.

Fig. 5: School field as a place of assembly at SMK Abdullah Munshi

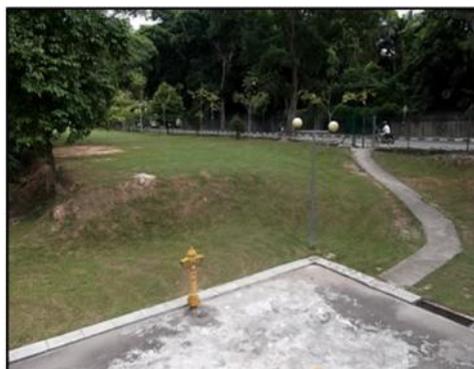
Fig. 6: Place C as a place of assembly for SJK (C) Min Sin

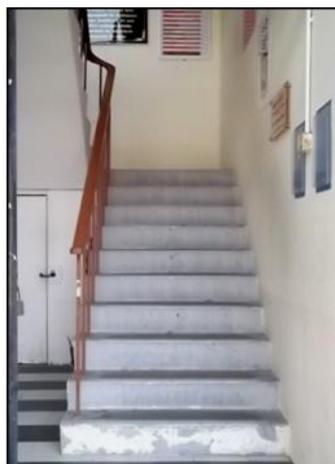
The school buildings have at least two staircases in every block. The size of the staircases, the length and width all follow the requirements in the UBBL. The width of the staircases is maintained throughout the entirety of its length, including the platform. By-law 168 stipulates that every upper floor shall have at least two separate exit staircases and the distance in between two exit staircases shall not be less than 5 metres. Figure 6 shows that the staircases in both schools are in good condition.

Fig. 7: The staircases are in good condition with no obstructions preventing the passage

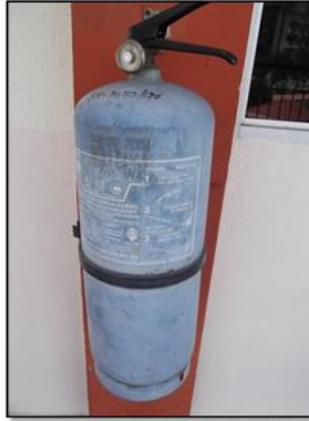
The management has made an inspection schedule to check and update expired fire safety equipment, particularly the fire extinguishers. SJK (C) Min Sin regularly maintains the fire extinguishers twice in a year, while SMK Abdullah Munshi updates their fire extinguishers once a year. It was observed that a few fire extinguishers were not maintained and had been left unattended for a few years. Figure 8 shows the poor condition of the fire extinguisher. The hose is also not in its proper place. These conditions show that there is a lack of maintenance and awareness from the management on the importance of fire safety equipment installations in the building.

Fig. 8: The expired portable fire extinguisher is still in use for one part of the building

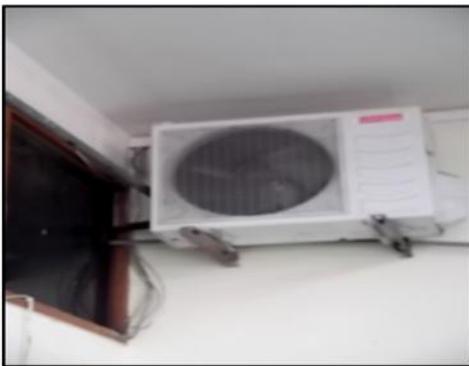
Lack of maintenance and inspection of electrical wires has left some wires sticking out and unattended. Fires caused by faulty or malfunctioning wiring could be easily spread or quickly get out of control. Figure 9 shows the electrical wires for an air-conditioner which are scattered and exposed on the outside of the building. Figure 10 shows the old wires that caused the original fire, charring from which can be seen on the wall. Before the fire incident, the school cut the old wires without knowing that they were still active and exposed to the weather. Exposure to rain water caused circuits to short, which eventually led to a fire.

Fig. 9: Scattered wires are left unattended

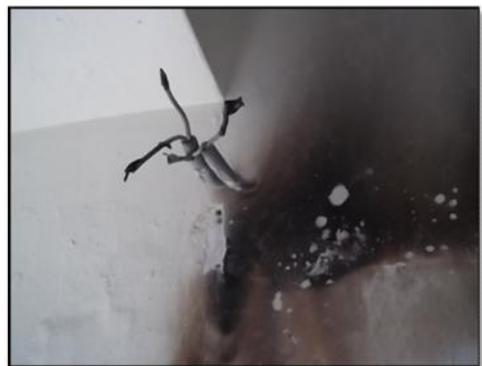
Fig. 10: Old wires that cause short circuits and fire
